# CA2515-3 AND CA2515-4 2007-2015 Silverado 2 Wheel Drive Only

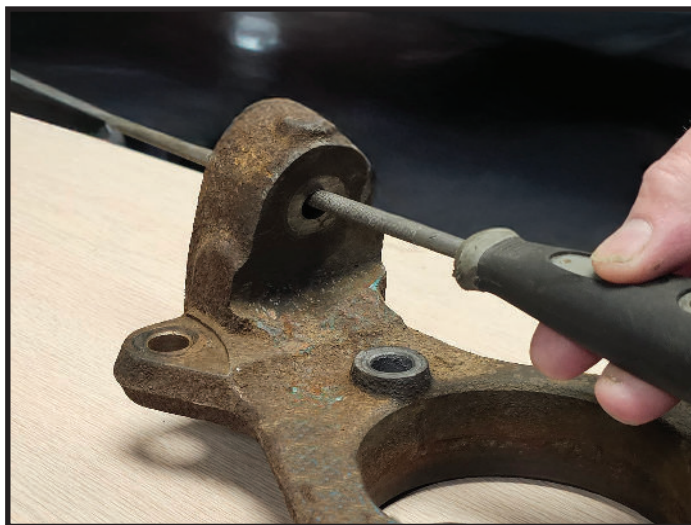
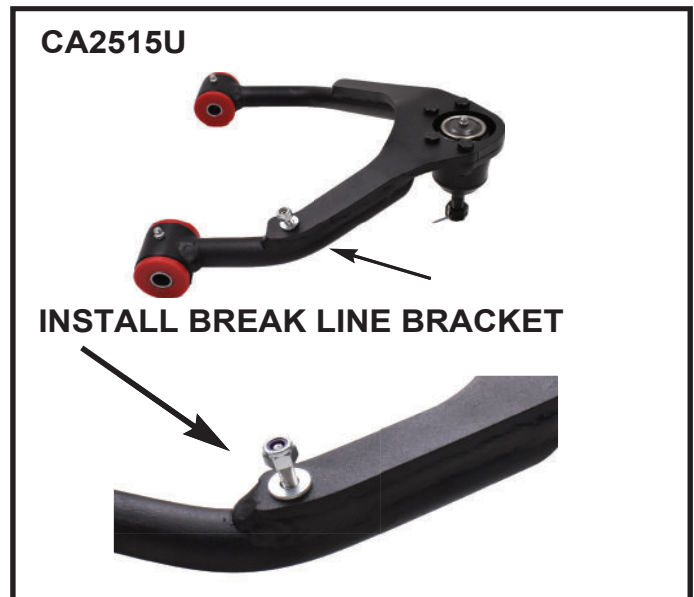
On 2016-2018 steel knuckle only. There is a small burr on the upper ball joint taper. This can be removed with a file or a die grinder. Test fit the upper ball joint to make sure there is no interference.
