# CA2515-3 AND CA2515-4 2016-2018 Silverado 2 Wheel Drive Only

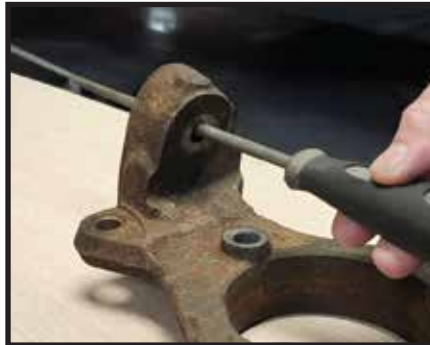
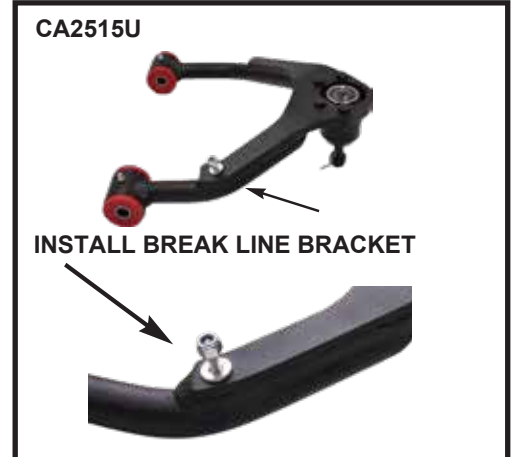
On 2016-2018 steel knuckle only. There is a small burr on the upper ball joint taper. This can be removed with a file or a die grinder. Test fit the upper ball joint to make sure there is no interference.
